## PROJECT DESCRIPTION

NORTHAMPTON STREET  
TOLL-SUPPORTED BRIDGE REHABILITATION

GENERAL PLAN, ELEVATION &  
INDEX OF DRAWINGS

**ASHE 2024 Project of the Year Award  
Northampton Street Toll-Supported Bridge Rehabilitation**

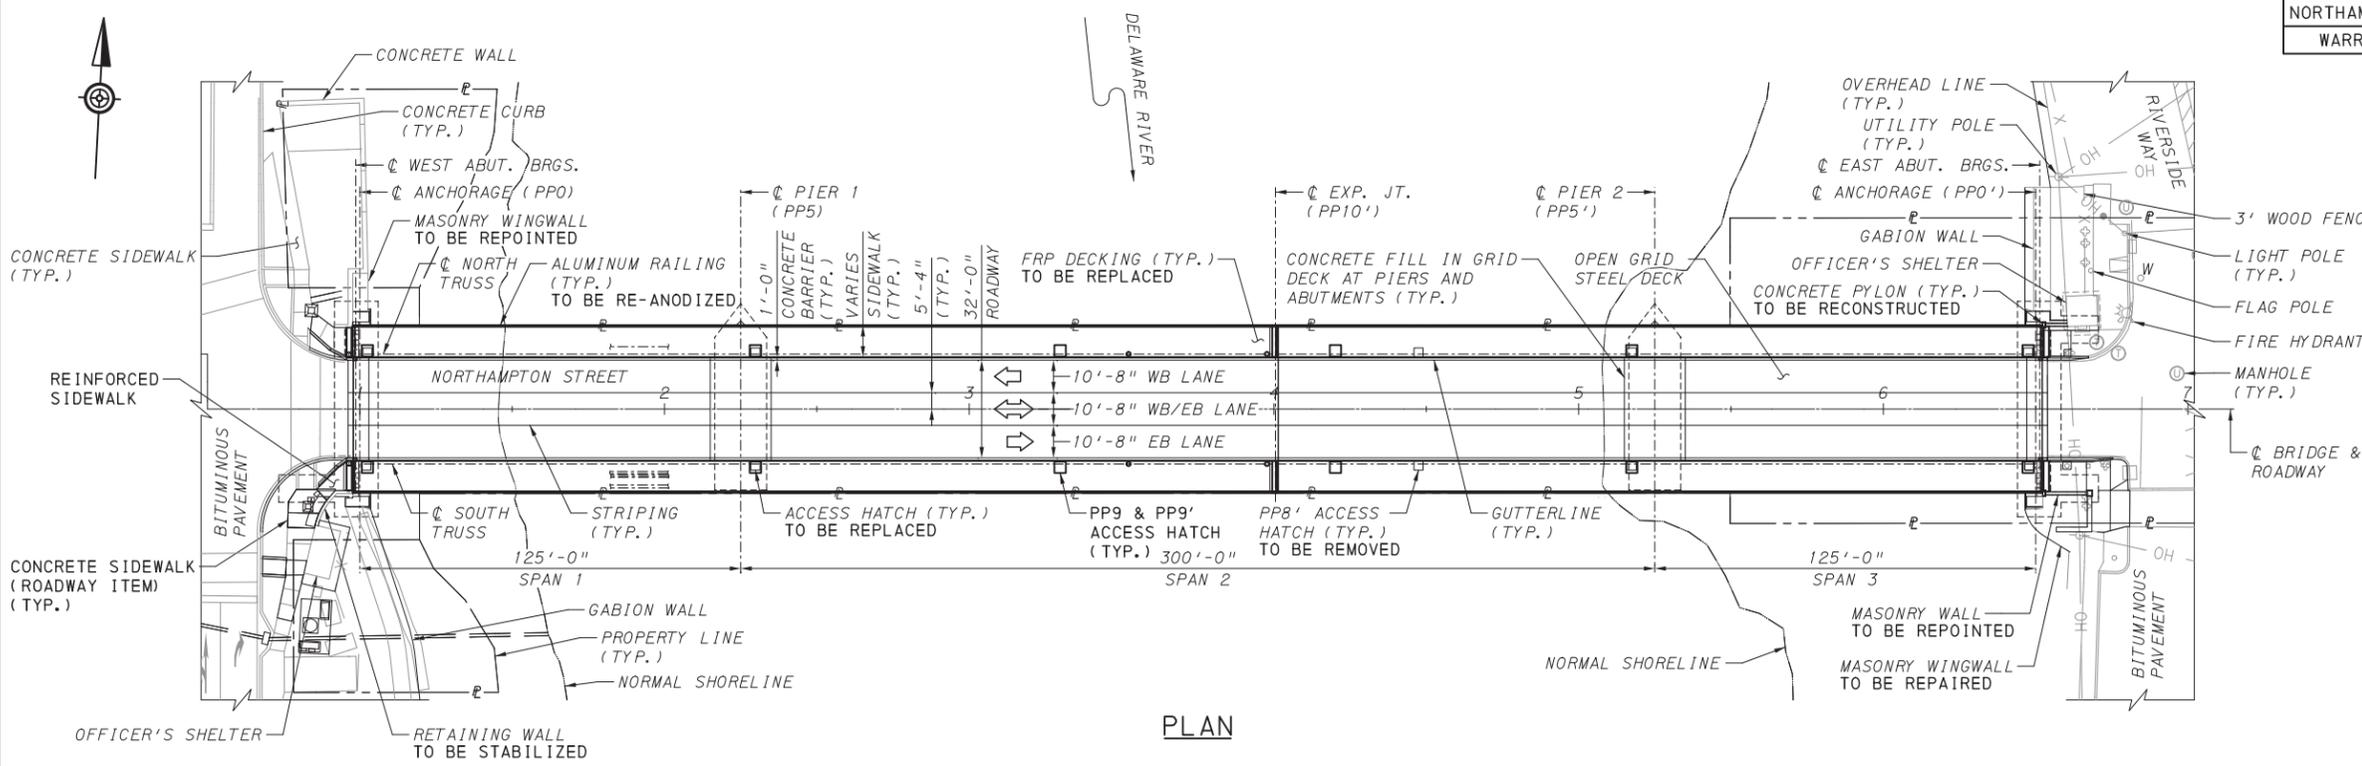
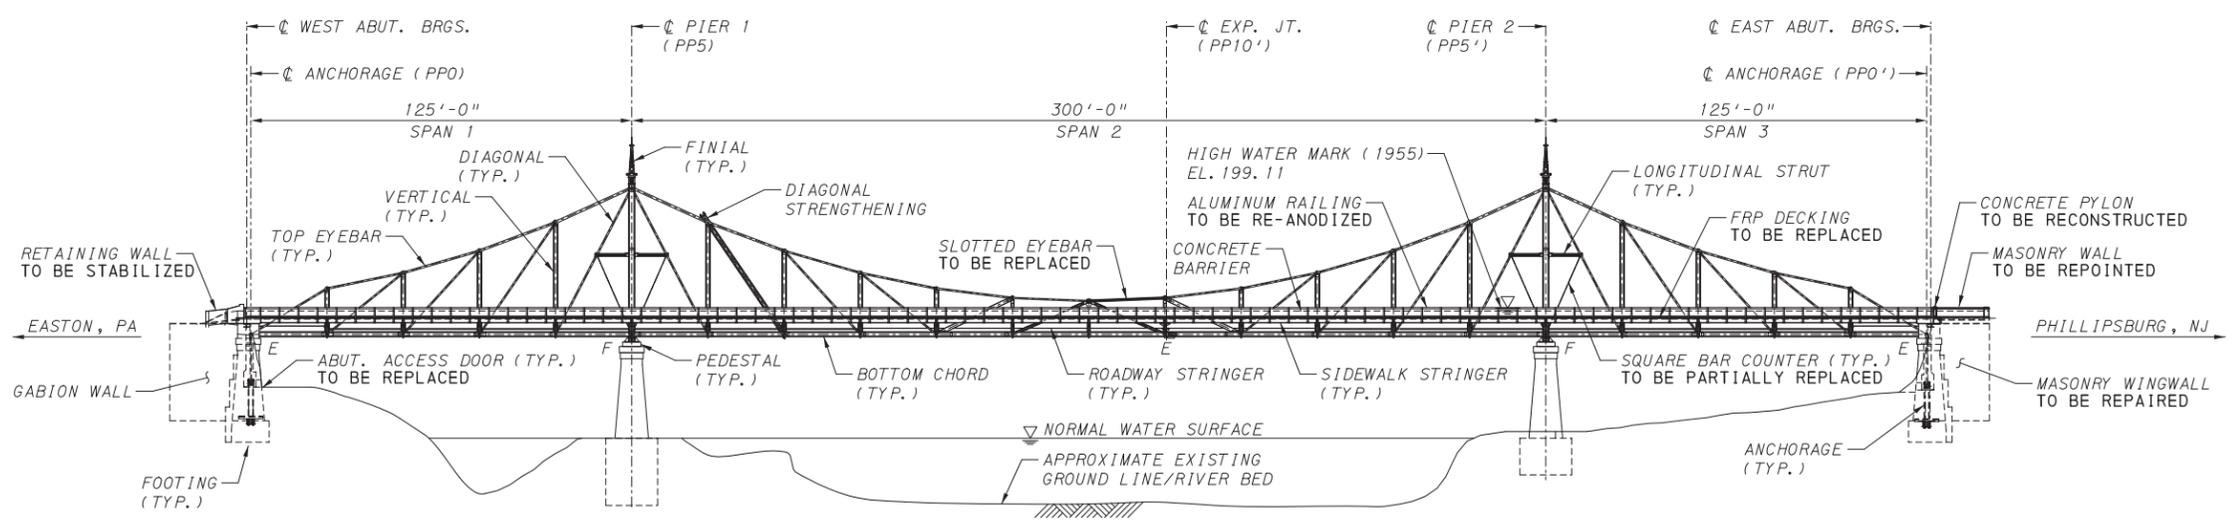
INVENTORY LOAD RATINGS (TONS)	
ELEMENT	H2O LOADING
TRUSS	14.7
STRINGERS	14.5
FLOORBEAMS	12.0

- RATING NOTES:**
- THE BRIDGE IS CURRENTLY POSTED FOR 3 TONS.
  - RATINGS UTILIZE LFR METHODOLOGY. TRUSS AND STRINGER RATINGS OBTAINED FROM 2019 PENNONI REHABILITATION STUDY SUMMARY REPORT.

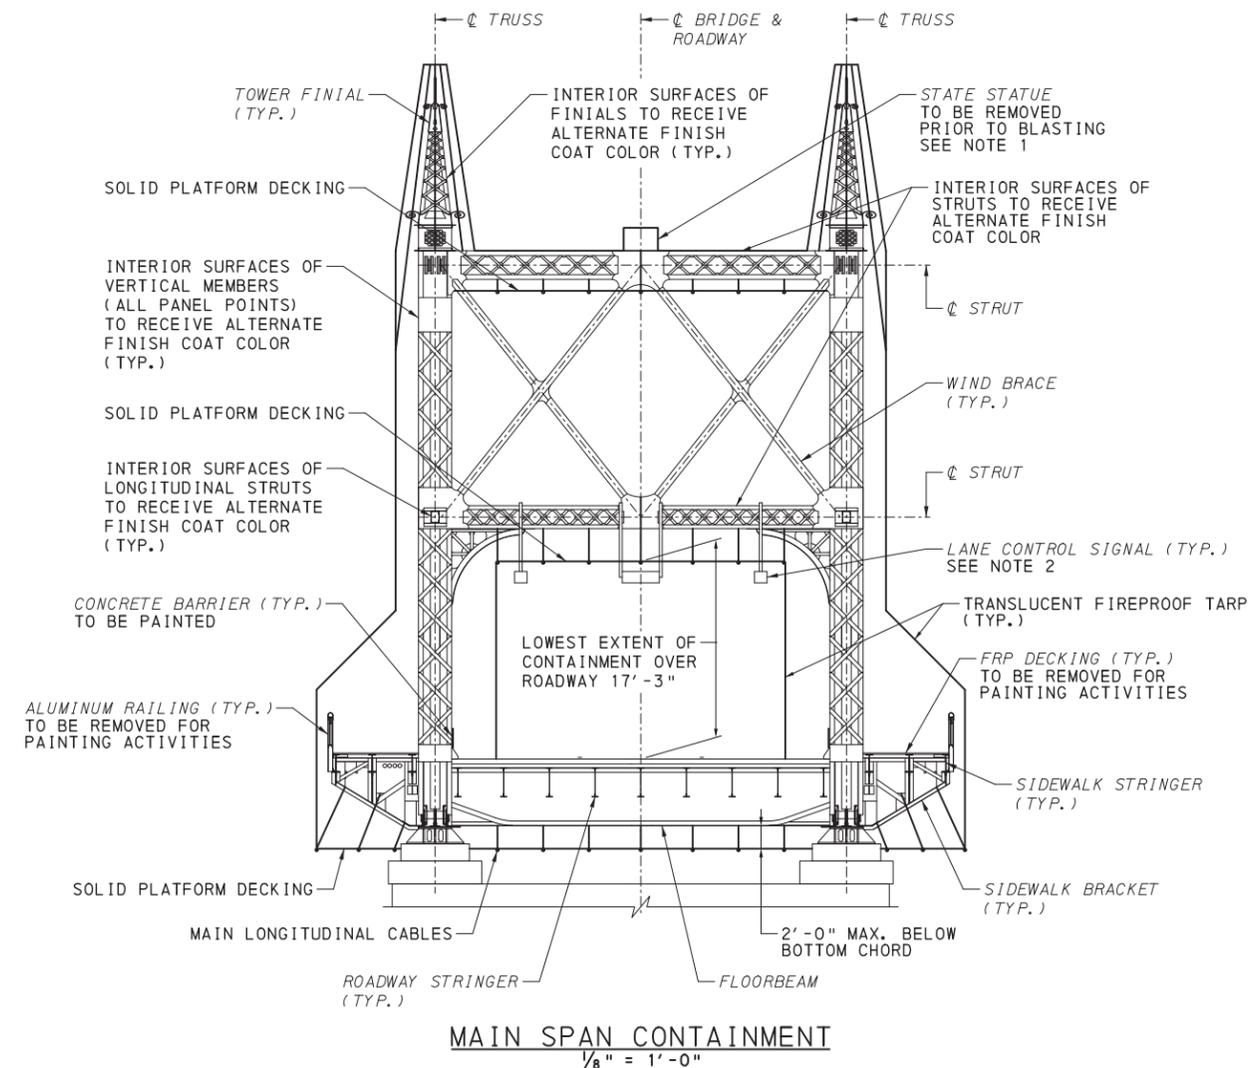
**MAIN SPAN CONTAINMENT**  
1/8" = 1'-0"

- STATE STATUES ARE TO BE REMOVED, DELIVERED FOR RE-GILDING, PICKED UP FROM GUILDER, AND REINSTALLED UPON COMPLETION OF PAINTING.
- LANE CONTROL SIGNALS ARE TO BE MAINTAINED DURING CONSTRUCTION.
- THE CONCEPTUAL CONTAINMENT SCHEME IS SHOWN FOR INFORMATION PURPOSES. THE CONTRACTOR IS RESPONSIBLE FOR DESIGN AND APPROVAL OF THE PROPOSED SYSTEM.

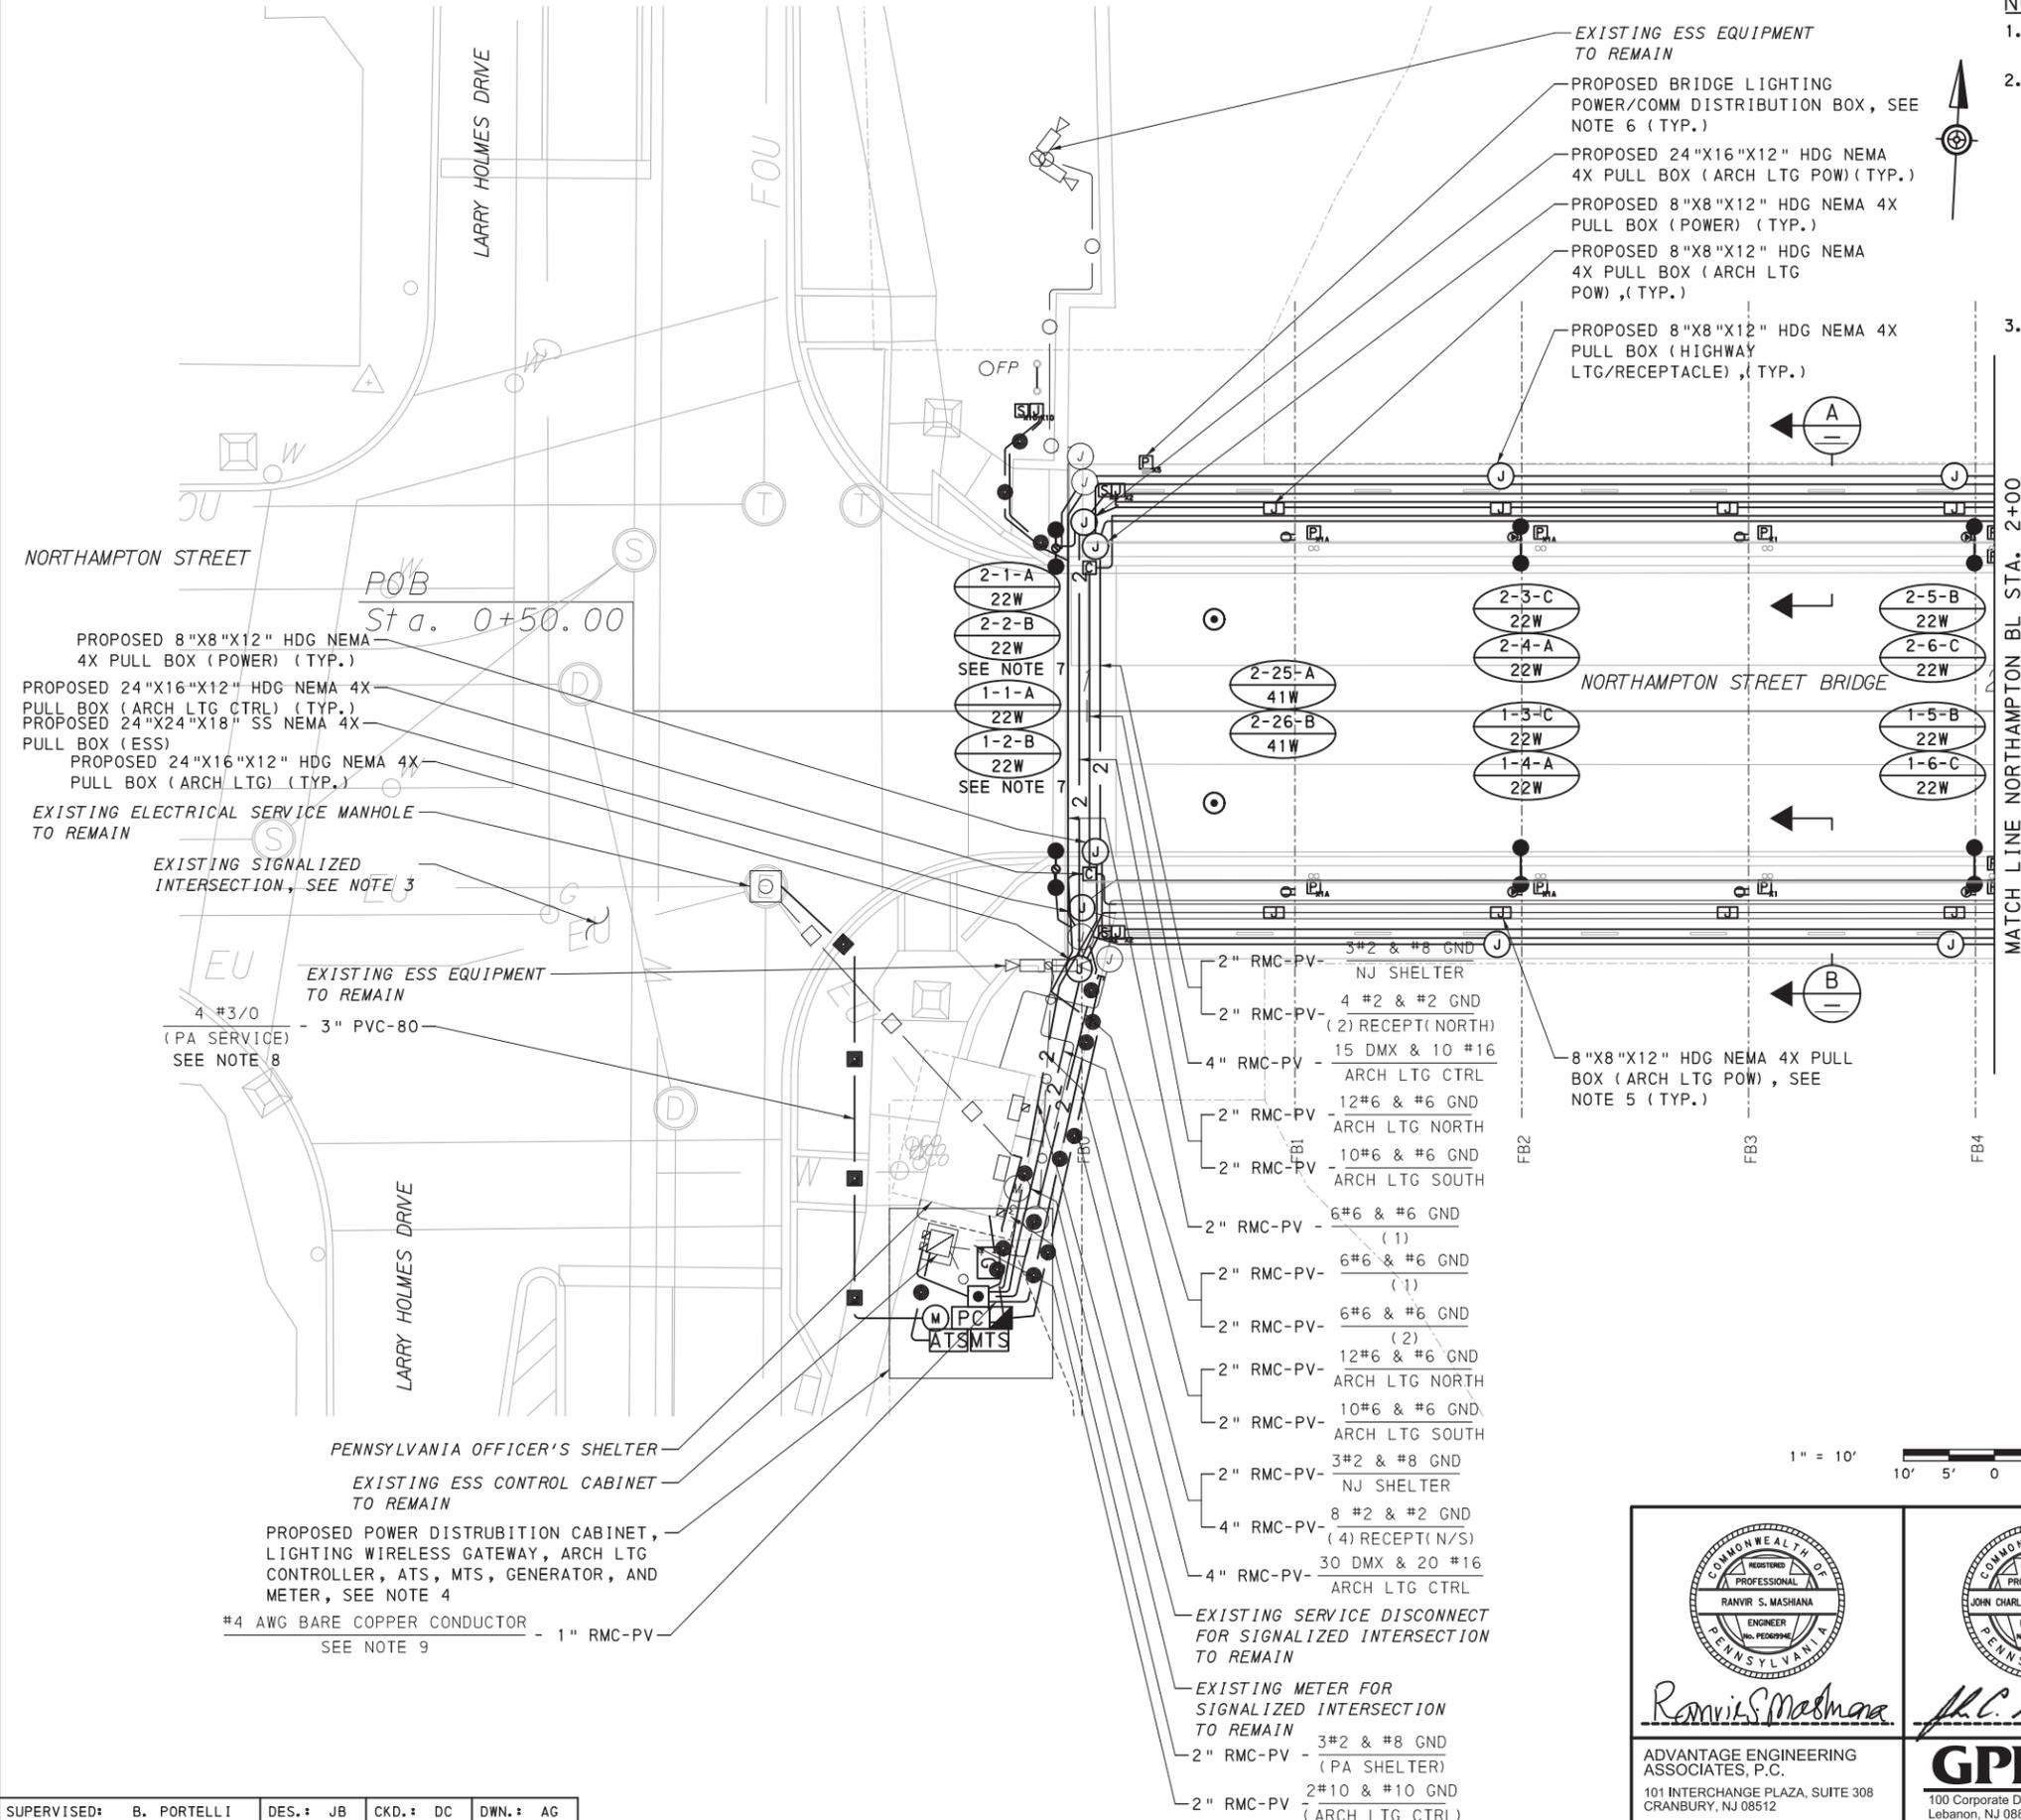
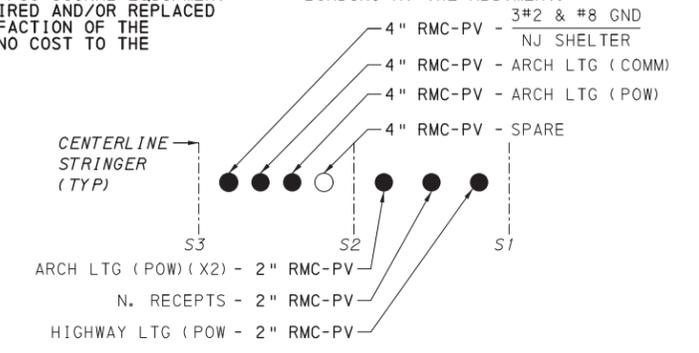
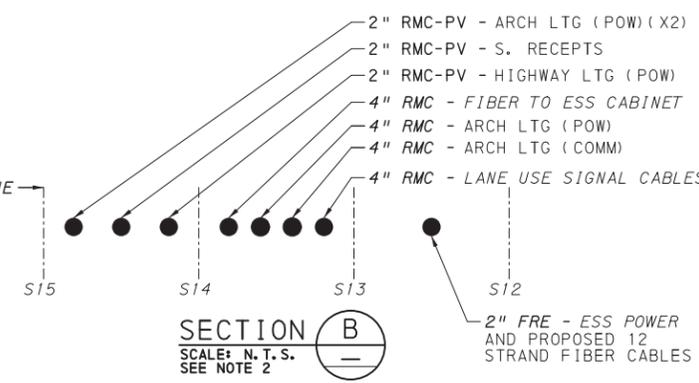
**HIGHWAY LIGHTING PLAN - 1**

- SEE SHEETS 33 THROUGH 35 FOR POWER DISTRIBUTION CENTER, ATS, MTS, AND METER ELECTRICAL SERVICE PAD DETAILS.
- INTERCEPT EXISTING 4" CONDUIT AND INSTALL 8"X8"X12" HDG NEMA 4X PULL BOX. SEE SHEETS 36 AND 37 FOR TYPICAL BRIDGE RACEWAY MOUNTING DETAILS.

- UTILIZE CONDUIT BODIES TO ROUTE DMX CABLES TO AND FROM ARCH LIGHTING POWER/DATA CONVERTER BOXES AND JUNCTION BOXES.
- SEE STRUCTURAL DETAILS ON RECONSTRUCTION OF WALL AND SIDEWALK FOR LIGHT POLE FOUNDATION DETAILS.

- FIRSTENERGY/MET-ED TO FURNISH AND INSTALL CONDUIT AND CABLE FROM MANHOLE TO METER. SEE SHEETS 32 AND 33.
- SEE SHEET 39 FOR GROUNDING AND BONDING AT THE ABUTMENT.
